# WHANGAMATA ACCESSIBILITY AUDIT REPORT

CCS DISABILITY ACTION

TAYLORED ACCESSIBILITY SOLUTIONS LTD

MAY 2014

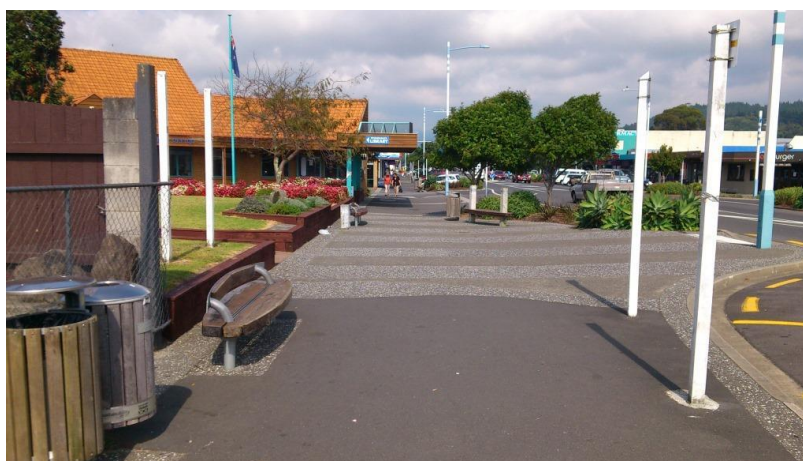
Figure 1: Port Road Improvements

Shop owners take pride in the town by minimising footpath clutter and maintaining access routes. Council has contributed by installing a textured footpath surface on Port Road, and a bypass diverting traffic from the town centre has created a more pleasant shopping environment.

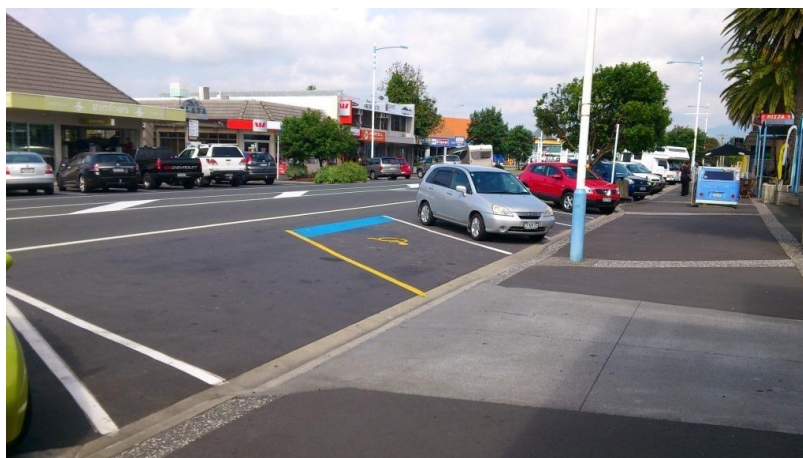
**Figure 2: Mobility Space on Port Road**

Using Table 1 above, this meets the requirements in NZS 4121:2001.

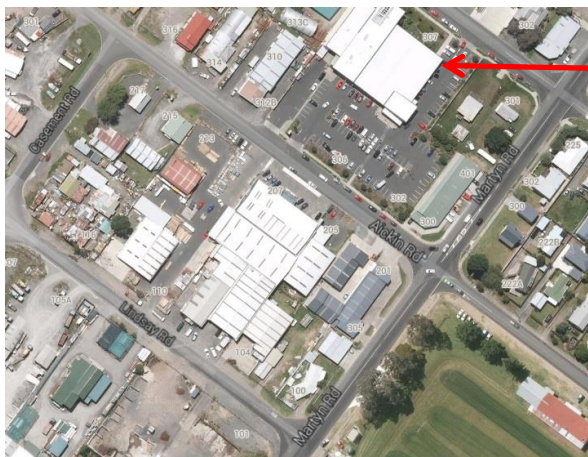
**Figure 4: Shopping Centre at Aicken Road**

The shopping centre includes a supermarket, building warehouse, veterinary hospital etc. the majority of the businesses have off-street parking, allowing for access users to park near the shop entrance. This can cause a concern if, for example, parking and shopping at the supermarket, then needing to shift the vehicle to access the Vet. Installing Mobility Spaces in the road reserve will improve access for access customers to these shops without the need for moving their vehicle.

**Recommendation 3** Install a Mobility Space on Aicken Road and Casement Road, between Martyn Road and Casement Road.

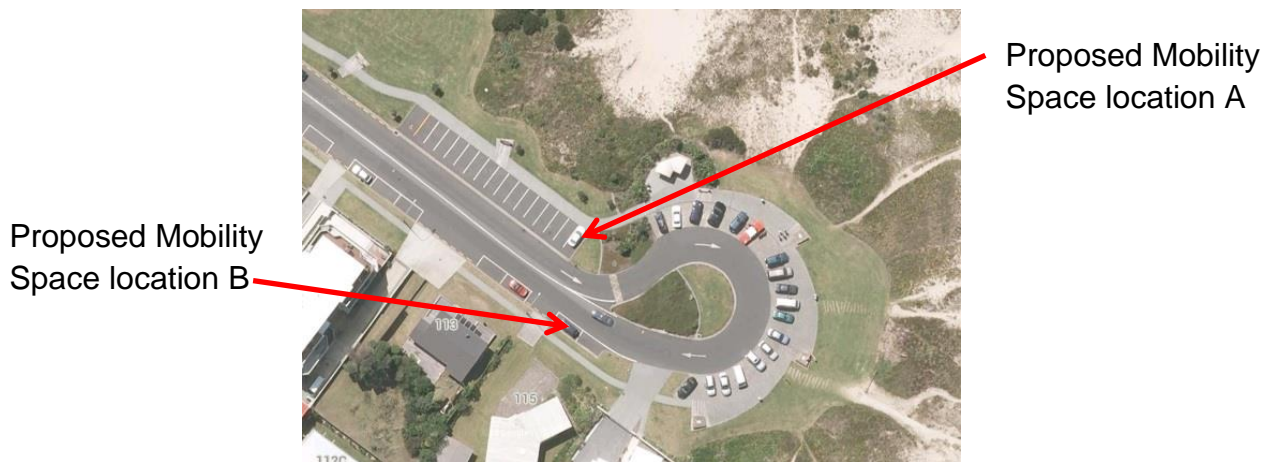
**Figure 5: Proposed Mobility Space locations at Beach Access 5, Hunt Road**

Mobility Space location A – Replace two 90° carparks with one Mobility Space. Installing a Mobility Space in this location will improve access to the boardwalk and the Public Toilets.

Mobility Space location B – Replace two parallel carparks with one Mobility Space. This will provide another option for Mobility Space users who prefer this type of parking. Users for this type include passenger side door users that need the extra space that the berm provides. Replacing two carparks will provide the length to rear loading vehicles to safely access the site without loading and unloading in the live traffic lane.

**Recommendation 4** Install two Mobility Spaces as shown Figure 5 at Beach Access No.5 on Hunt Road.

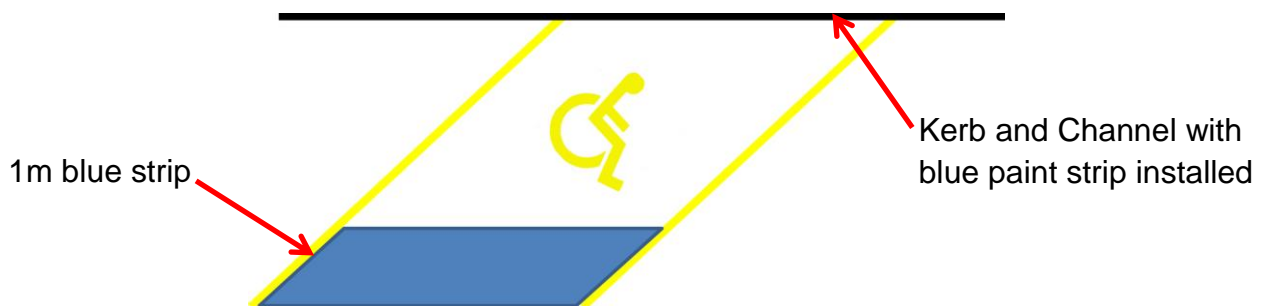
**Figure 8: Mobility Space with blue surfacing design**

A 1m strip for the length of the road edge of the carpark will provide visual notice to road users, reduce installation costs, and reduce the need for repair when replacing kerb and channel etc.

During the consultation process where this was suggested, concern was raised about visibility of the mobility parking space from the footpath. Installing a blue coloured metal plate or a blue strip on the top of the kerb will aid pedestrians to 'police' the spaces.

**Recommendation 10** Continue the programme to mark Mobility Spaces with blue surfacing. Installing blue marking as per figure 8 will aid with maintaining a non-slip surface with the colour of both the surface and the marking to comply with Land Transport Rule: Traffic Control Devices 2004.

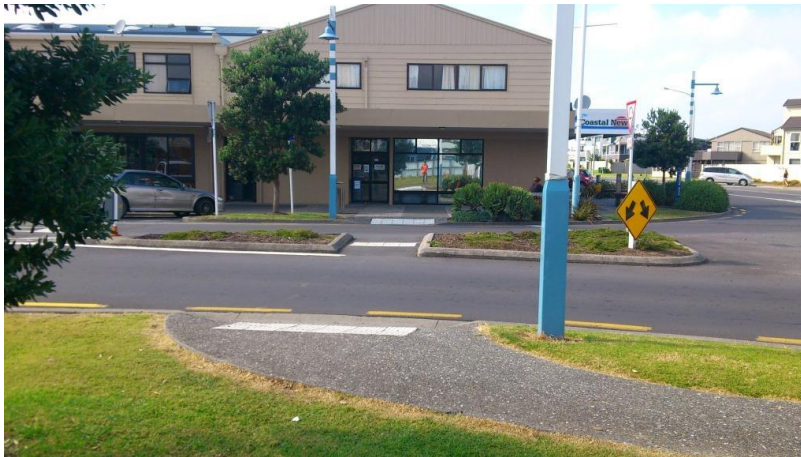
**Figure 9: Crossing Port Road north of Hunt Road/Hetherington Road**

Similarly, the grade crossing Hetherington Road at the SW corner was measured at 1 in 9.3 (10.8%).

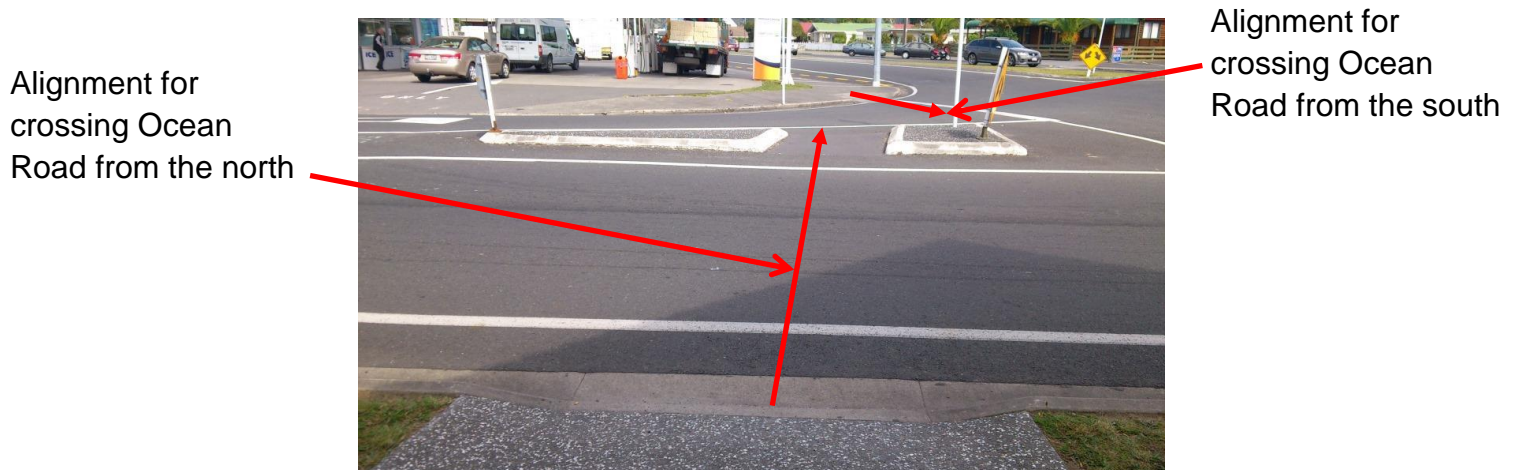
**Figure 10: Port Road/Ocean Road crossing point.**

The kerb ramps crossing Ocean Road are not in alignment and have grades of 1 in 6.9 (14.5%) for the NE corner and 1 in 7.5 (13.3%) for the SE corner. Alignment is critically for visually impaired users and this is discussed further in Section 9: Tactiles.

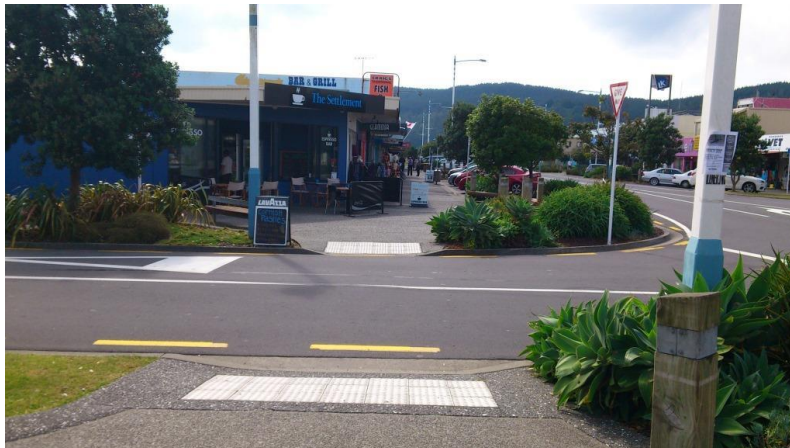
**Figure 11: Crossing Casement Road at Port Road**

- NW corner Casement Road – 1 in 10.6 (9.4%); and
- SW corner crossing Casement Road – 1 in 7.9 (12.6%).

Re-grading the kerb ramps to a maximum of 1 in 14 (7.1%) will improve the use and safety of this intersection for mobility scooters and wheelchair users.

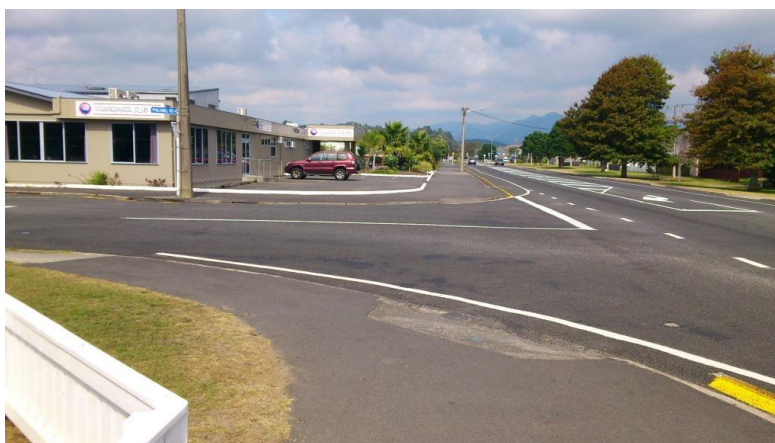
**Figure 12: Port Road/Philomel Road intersection**

- SW corner – 1 in 6.5 (15.4%); and
- NW corner – 1 in 7.4 (13.5%).

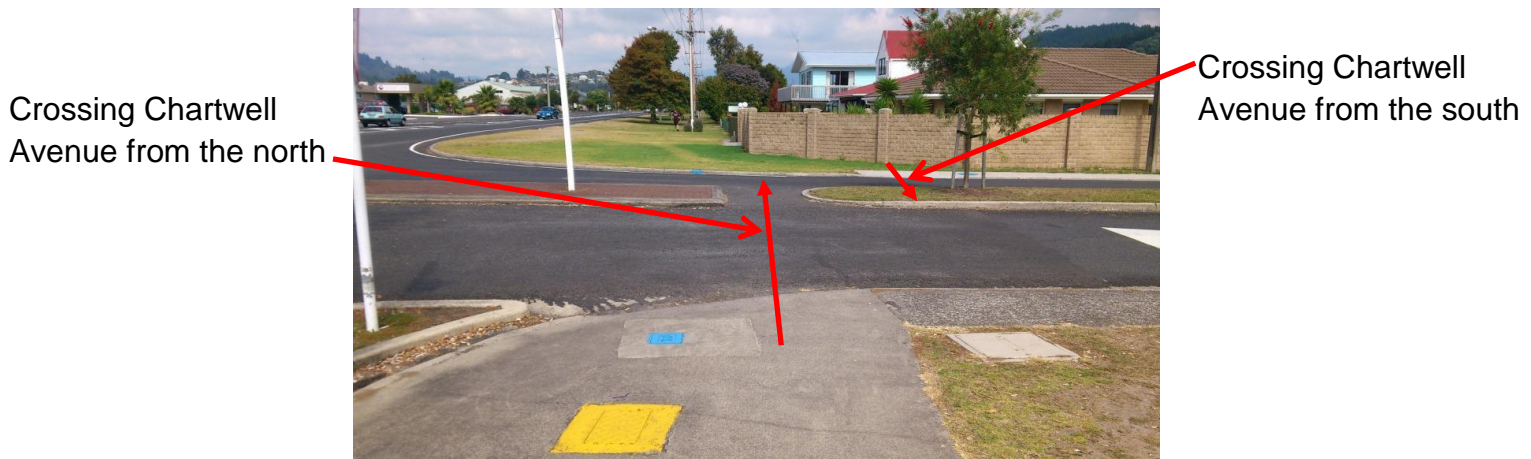
**Figure 13: Crossing Chartwell Avenue at Port Road**

Like at Port Road/Ocean Road intersection, the kerb ramp on the SE crossing Chartwell Avenue is not in alignment while the NE kerb ramp has a grade of 1 in 10.4 (9.6%). Alignment is critically for visually impaired users and this is discussed further in Section 9: Tactiles

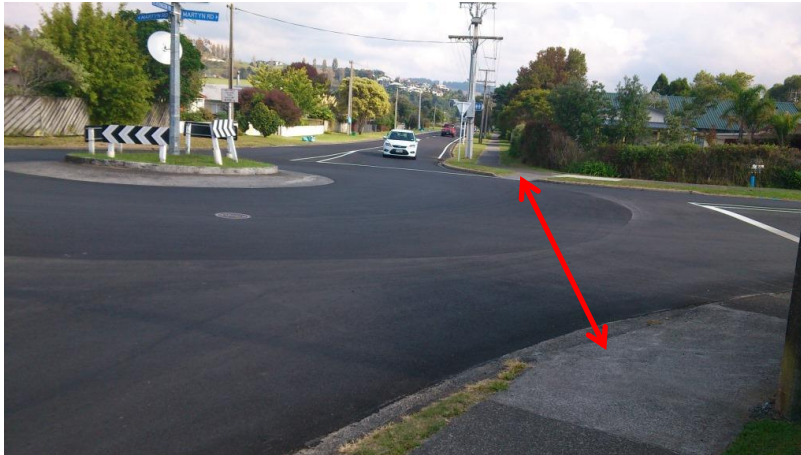
**Figure 14: Kerb ramps at Martyn Road force users into the live traffic lane**

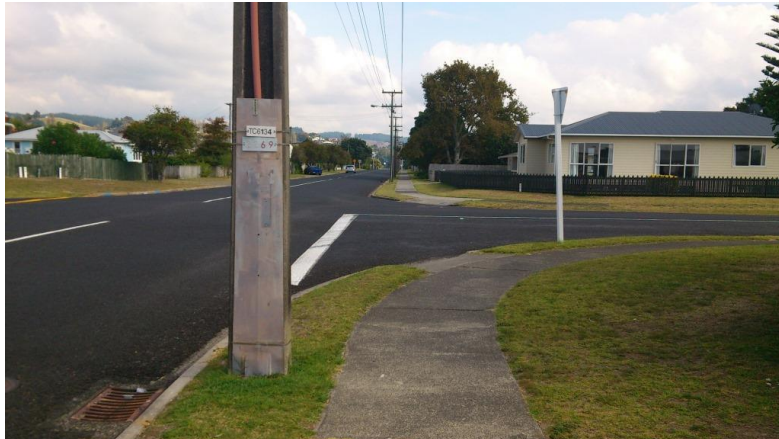
**Figure 15: Hetherington Road/Rutherford Road intersection**

Replacing the kerb ramps to a maximum grade of 1 in 14 (7.1%) will improve the link to the north end of town and Beach Access No.5 for residents from Moana House using mobility scooters.

**Recommendation 20** Replace the kerb ramps at the Hetherington Road/Rutherford Road intersection to have a maximum grade of 1 in 14 (7.1%).

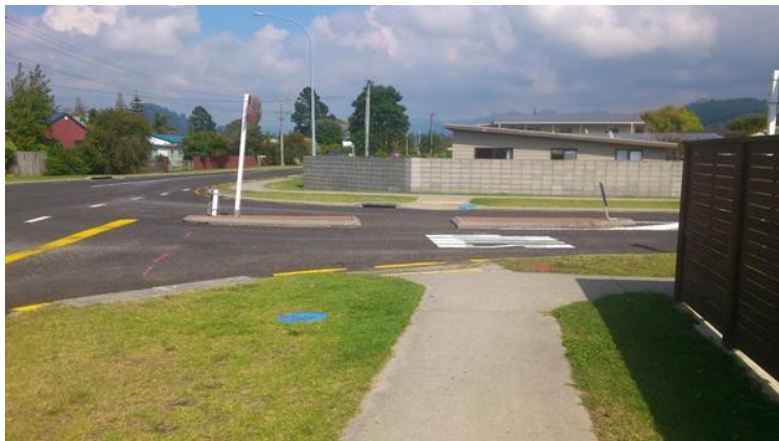
**Figure 16: Crossing Winifred Avenue at Barbara Avenue.**

- The NE kerb ramp crossing Barbara Avenue is a grade of 1 in 9.4 (10.6%);
- The NW kerb ramp crossing Barbara Avenue is a grade of 1 in 8.5 (11.7%);
- The NW kerb ramp crossing Winifred Avenue is a grade of 1 in 8.4 (11.9%); and
- The SW kerb ramp crossing Winifred Avenue is a grade of 1 in 7 (14.2%).

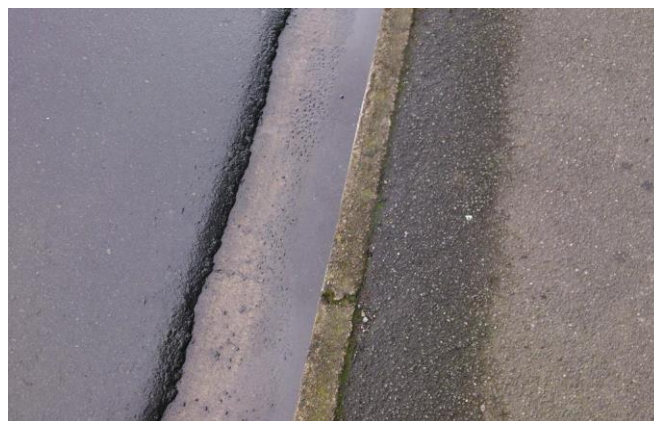
**Figure 17: Seal edge join after re-sealing**

Re-sealing the carriageway can create a small lip where joining the kerb channel. This can require a wheelchair user to stop in the channel before negotiating the barrier. Milling the seal edge before re-sealing can eliminate this problem.

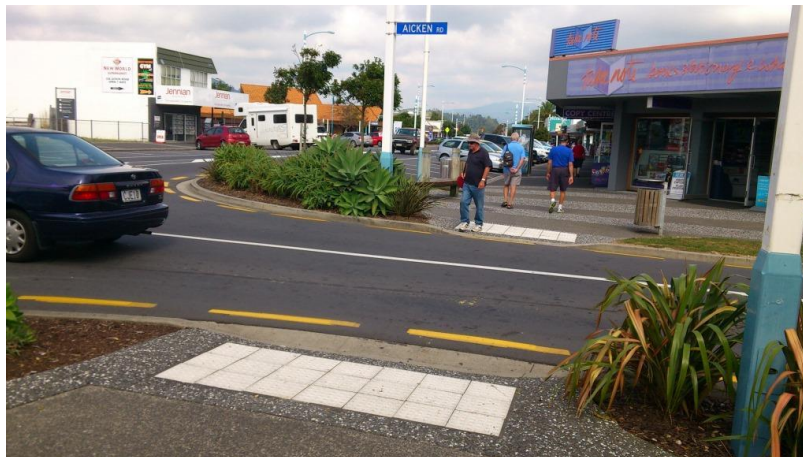
**Figure 19: Port Road/Aicken Road intersection**

- Port Road/Hetherington Road/Hunt Road – all Tactiles;
- All mid-block crossing points on Port Road;
- Port Road/Winifred Avenue – crossing Winifred Avenue;
- Port Road/Casement Road – crossing Casement Road;
- Port Road/Aicken Road – crossing Aicken Road;

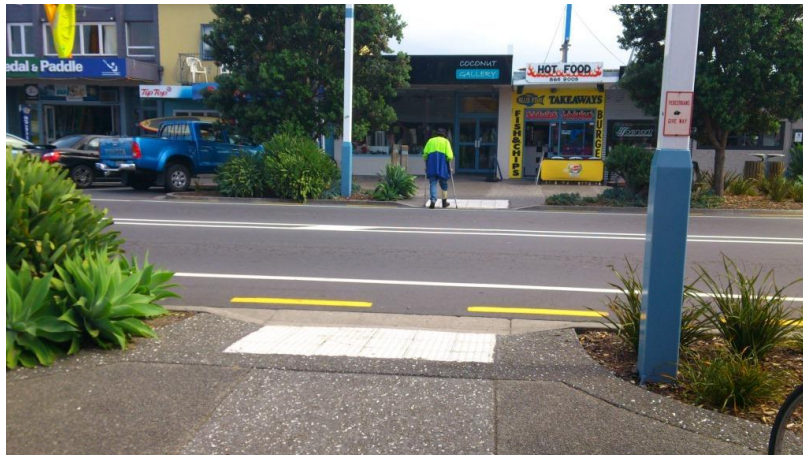
**Figure 21: Tactile at a crossing point on Port Road**

The intersection of Port Road/Ocean Road (both sides crossing Ocean Road) requires the installation of both Warning Indicators and Directional Indicators.

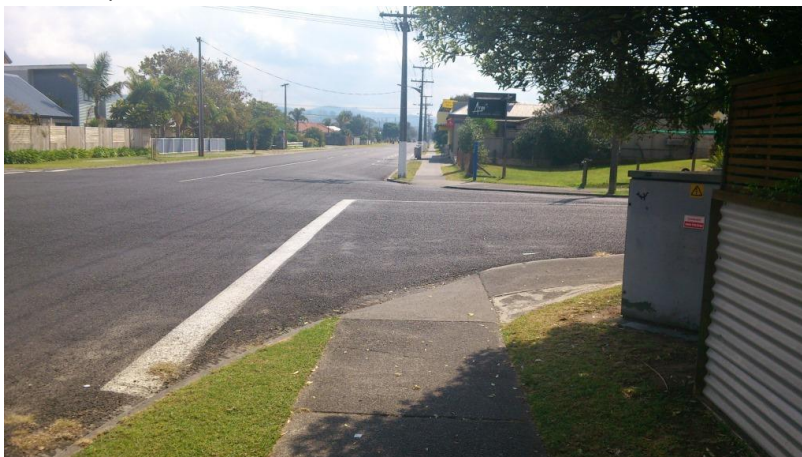
**Figure 22: Ocean Road/Graham Street intersection**

- Ocean Road/Barbara Avenue – both sides crossing Barbara Avenue;
- Ocean Road/Short Road – both sides crossing Short Road; and
- Ocean Road/Graham Street – both sides crossing Graham Street (NW and NE).

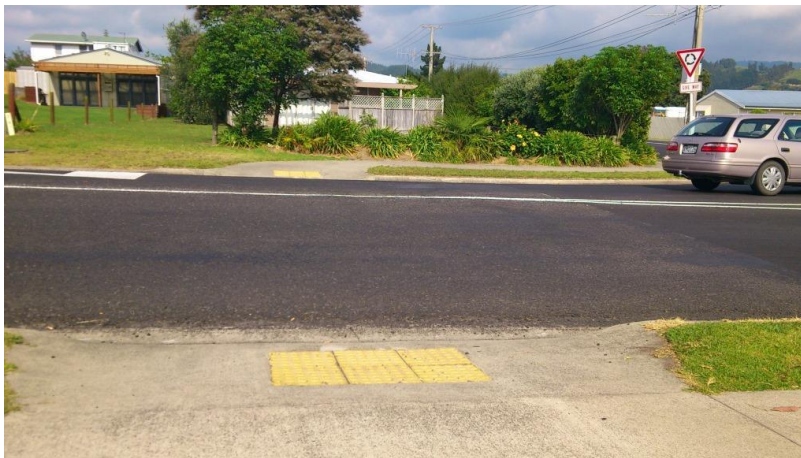
**Figure 23: Crossing Hetherington Road at Martyn Road**

The intersection of Hetherington Road/Martyn Road requires the installation of Directional Indicators only at the crossing points of Martyn Road (north of roundabout) and Hetherington Road (east of Roundabout). Extra Warning Indicators are also required crossing Hetherington Road (discussed in Section 9.16 Width of Warning Indicators).

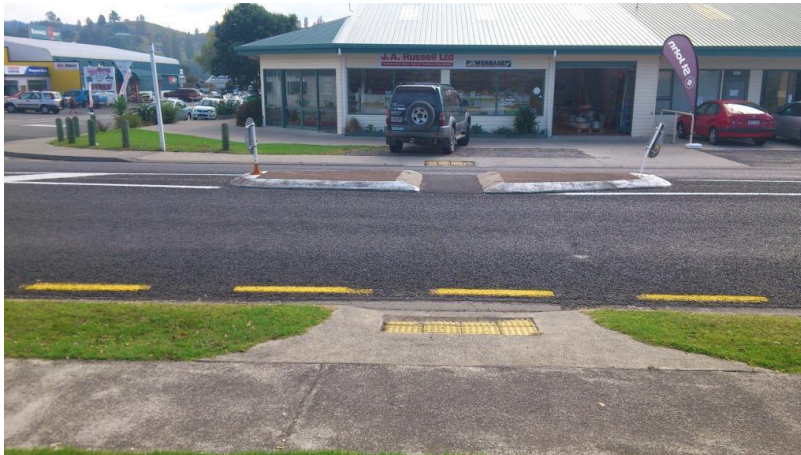
Figure 24: Refuge Island on Martyn Road, north of Aicken Road

Aicken Road requires Warning Indicators at Aicken Road/Rutherford Road intersection and Directional Indicators at the refuge island on Martyn Road, north of Aicken Road. The installation of Warning Indicators is required in the refuge island while the Warning Indicators on the kerb ramps at the refuge island will need replacing due to sinking of the tiles.

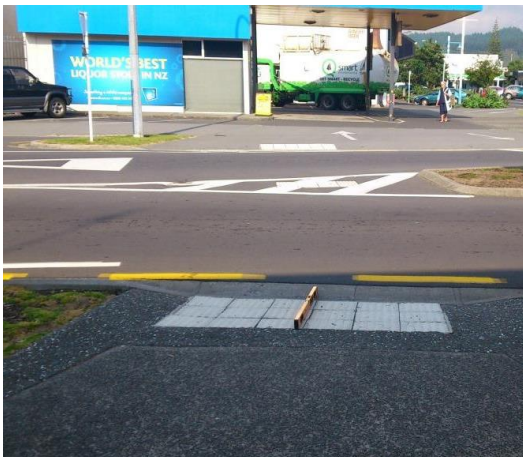
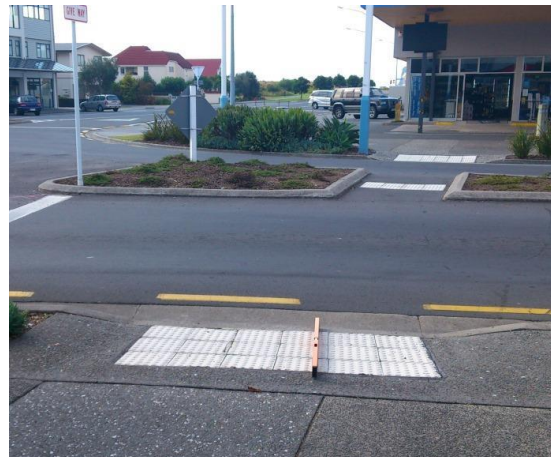
**Figure 25: Crossing Hunt Road and Port Road**

Of the intersections with Tactiles already installed, the following need to have the alignment corrected:

- Port Road/Hetherington Road/Hunt Road – Crossing Hunt Road, Port Road and Hetherington Road; and

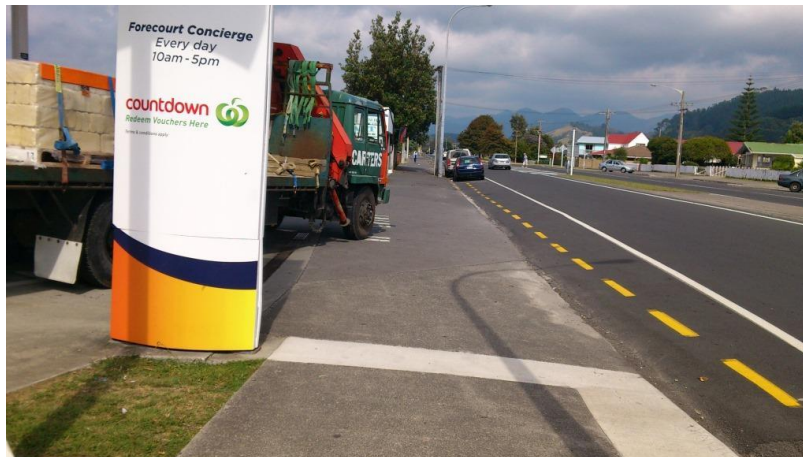
**Figure 26: Truck parked on footpath at Z Service Station at the intersection of Port Road and Ocean Road**

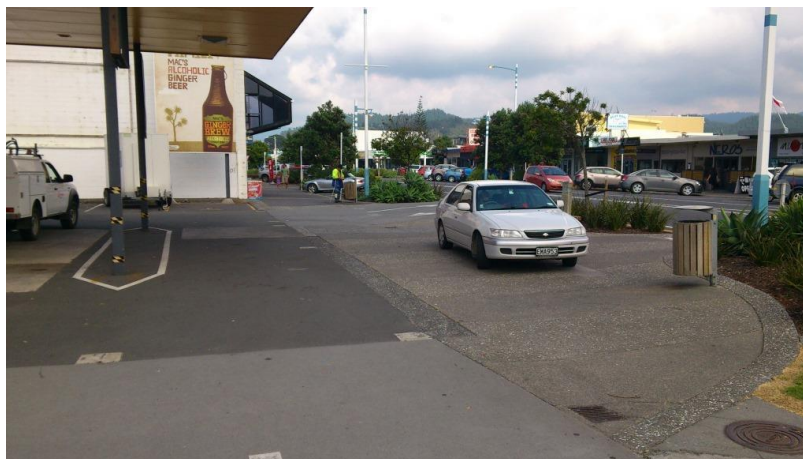
**Figure 27: Vehicle parked on footpath at Liquor King (Port Road/Hunt Road intersection)**

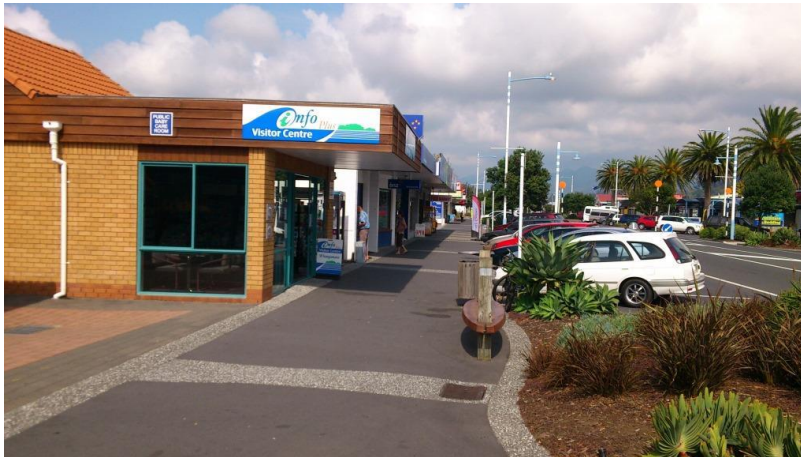
A number of improvements have been made to the footpaths in the main shopping centre of Whangamata. As a result, a combination of Asphaltic Concrete with exposed aggregate concrete patterns has been laid to create a softer, more appealing environment.

**Figure 28: Excellent footpath surface on Port Road**

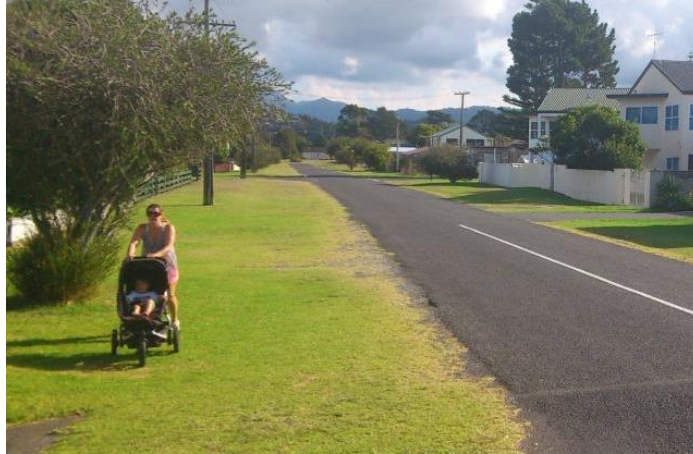
**Figure 29: Mother and child using the berm**

Given the locality and traffic volumes along these roads, installing footpaths on both sides of local roads would be deemed a low priority, long term plan. The short term plan should be to ensure sufficient access across the road can be achieved.

**Recommendation 40** Install footpaths on both sides of the road on the Collector Roads (Hetherington Road, Martyn Road, Ocean Road, and Port Road).

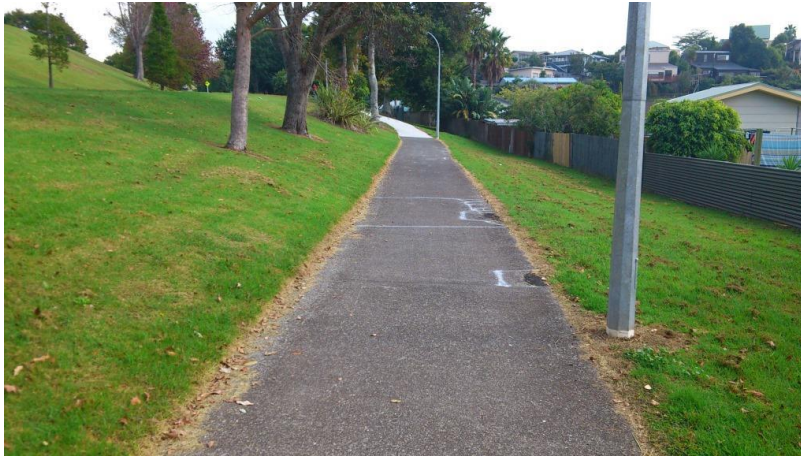
Throughout the site investigation, defects in the footpath were marked for repair. This was very pleasing to see as it shows TCDC has a good maintenance programme in place.

**Figure 30: Broken footpath identified for repair**

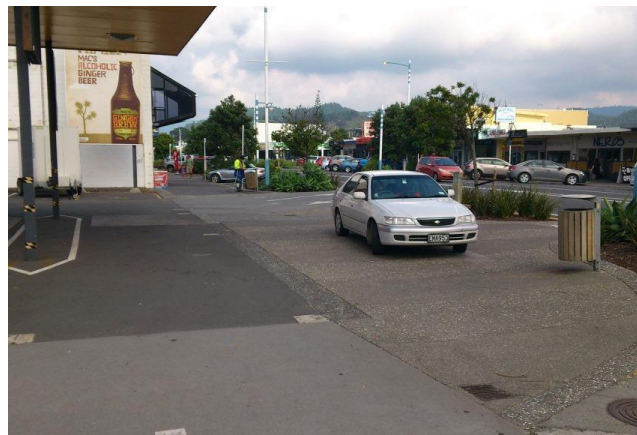
**Figure 31: Car parking on the footpath at Liquor King**

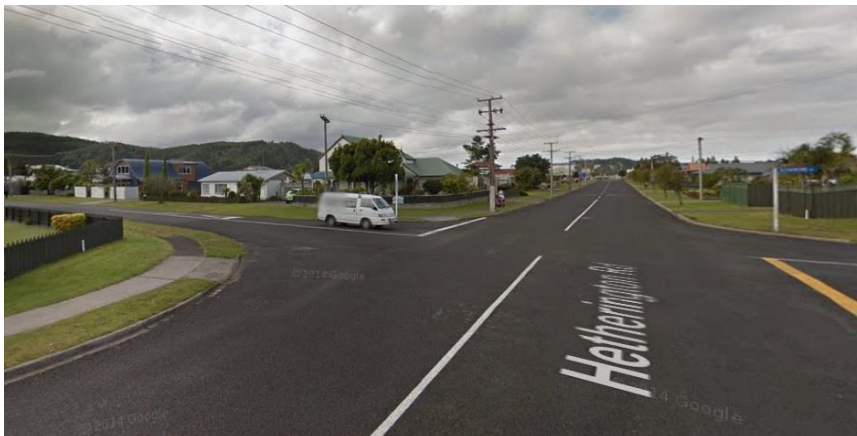
Figure 34: Hetherington Road

A crossing opportunity at this intersection will provide a safe connection from Rutherford Road to the footpath on Hetherington Road.

The ADT volume for Hetherington Road is approx. 2139 veh./day so it is highly likely kerb ramps will be sufficient, but a calculation using the Pedestrian Crossing Facilities Calculation Spreadsheet will determine the most suitable crossing facility.

**Recommendation 50** Use the Pedestrian Crossing Facilities Calculation Spreadsheet to determine the best pedestrian crossing facility at the Hetherington Road/Rutherford Road intersection.

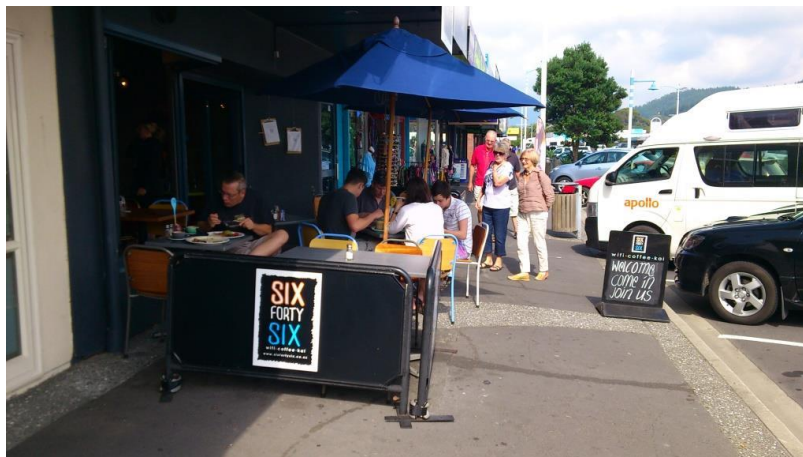
**Figure 38: Al-fresco dining on Port Road**

Businesses along Port Road regularly install street signage, stock and tables and chairs outside of their premises. This has implications for people with significant visual impairment as they frequently use environmental cues such as buildings to navigate around a community and they won't necessarily see stock that are low to the ground, they become a trip hazard.

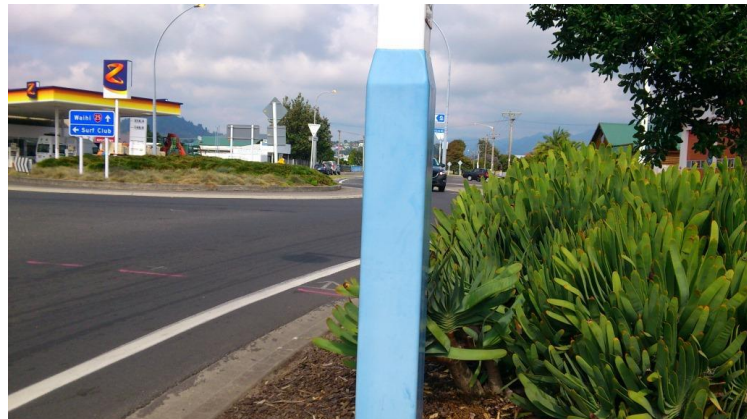
The major concern at the existing crossing opportunities on Port Road was the lack of sight distance caused by Light Poles at some of the crossings. Obstacles placed on the side that traffic approaches from cause difficulty for pedestrians to see the traffic.

**Figure 40: Light Pole affecting sight distance at Port Road/Ocean Road intersection**

The placement of Light Poles at the crossings inhibits the line of sight for both wheelchair and mobility scooter users and approaching vehicles.

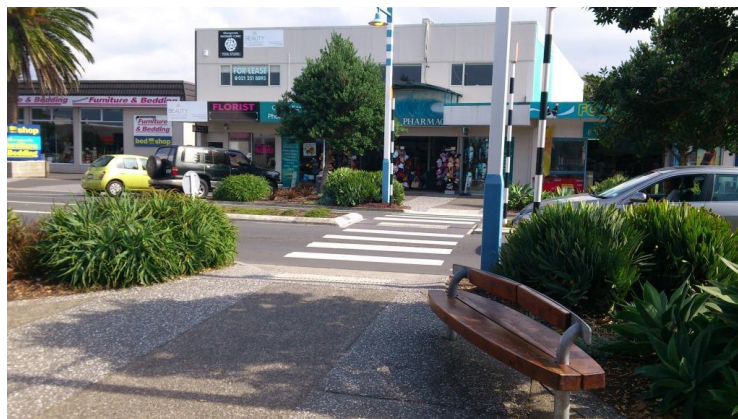
**Figure 41: Light Poles on the wrong side of the pedestrian crossing on Port Road**

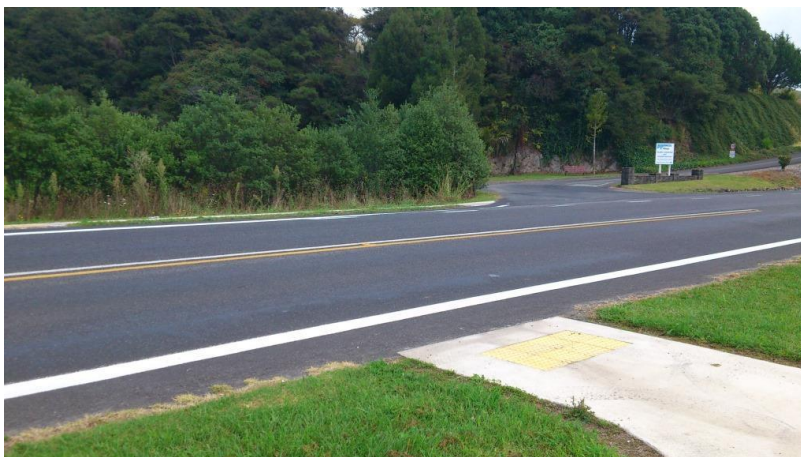
**Figure 42: Crossing SH.25 at Moana House**

The first obstacle for Moana House residents is having to negotiate crossing SH.25 immediately east of Moana House.

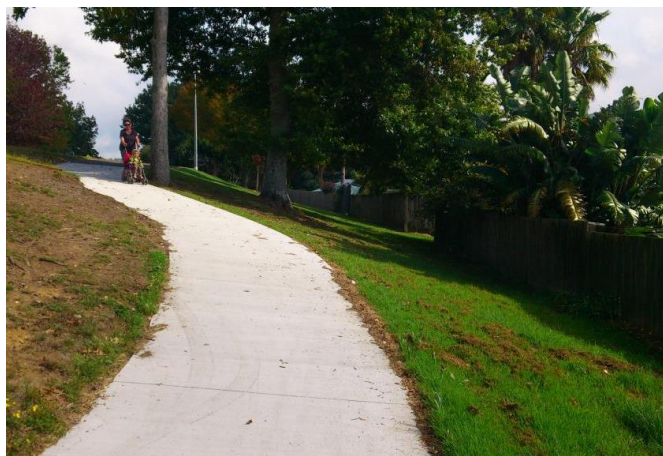
There is a section of footpath west of Moana Anu Anu Avenue is extremely steep and should not be used in its current grade of 1 in 5.9 (17%).

**Figure 44: Steep grade of footpath west of Moana Anu Anu Avenue**

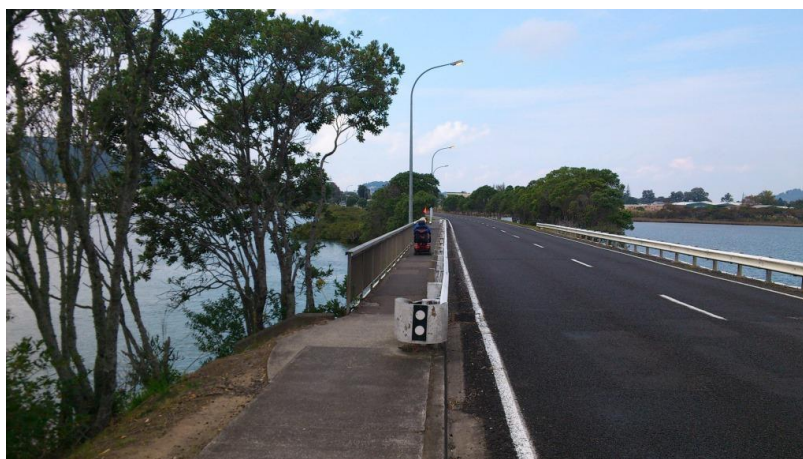
**Figure 45: Bridge footpath on Harry Watt Drive**

A bridge over the estuary links Harry Watt Drive to the township of Whangamata. A footpath is included on the north side of Harry Watt Drive. This is extremely narrow with a mobility scooter just fitting on the path.

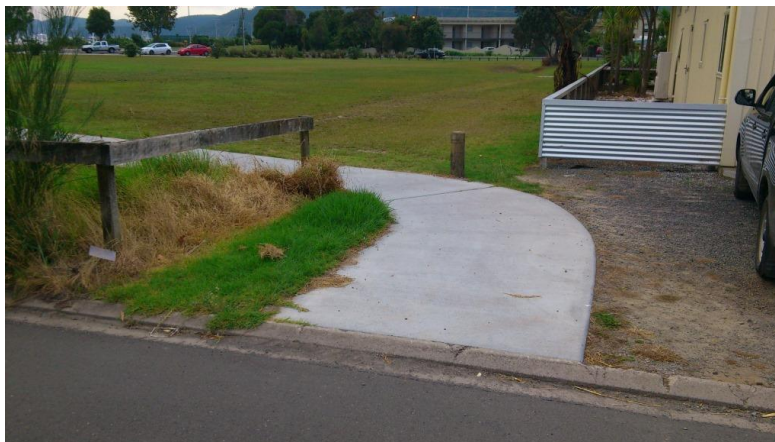
**Figure 47: Connection from Reserve to Casement Road**

While the connection to the path at the Hetherington Road is excellent, the connection to Casement Road is poor.

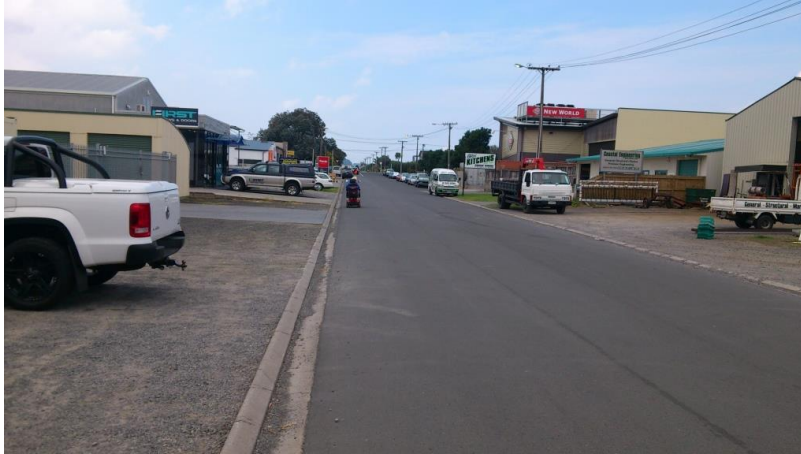
**Figure 48: Mobility scooter using the carriageway on Casement Road**

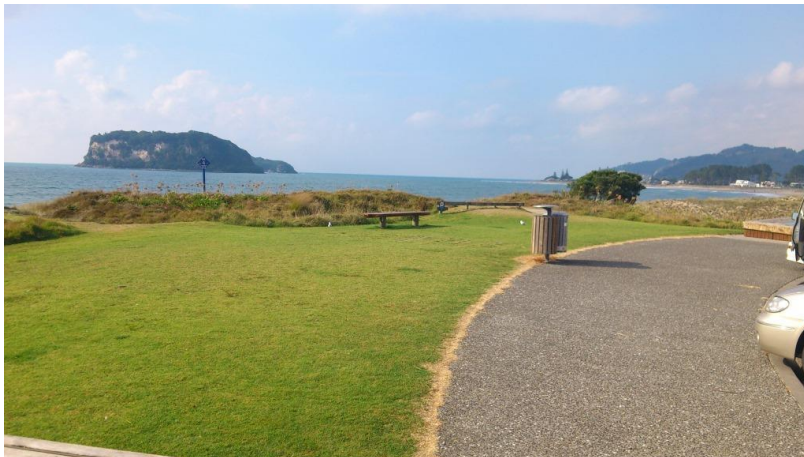
**Figure 49: Beach Access No.5**

Beach Access No.5 is located at the end of Hunt Road. A public toilet and good seating is available in this location.

By providing a 1.5m concrete path to the seats at the each of the sand dune, access will be improved.

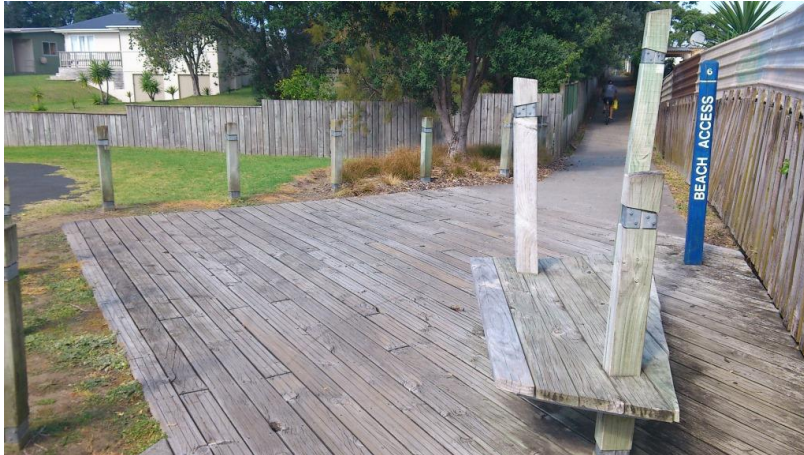
**Figure 50: Beach Access No.6**

Beach Access No. 6 provides connection from the centre of town to the Beach, approx. 500m east of Port Road. This walk utilises concrete path walkways and joins the beach at Mooloo Crescent.

A 2.5m concrete path is the absolute minimum for a shared cycle path/walkway. Widening the path to 2.5m (3m preferred) will improve the path for sharing with all users.

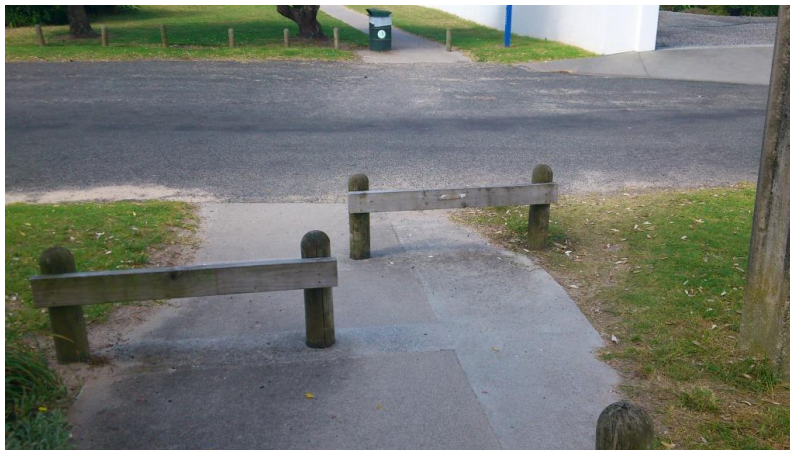
**Figure 51: Chicane barrier at Mooloo Crescent**

Widening the chicane barriers to a minimum 1.5m will aid mobility scooter users and mothers with pushchairs to use this path. Painting the barriers and bollards along the route yellow will aid visually impaired users.

**Recommendation 68** Widen the chicane barriers to 1.5m spacing and paint the barriers and bollards yellow for visually impaired users.

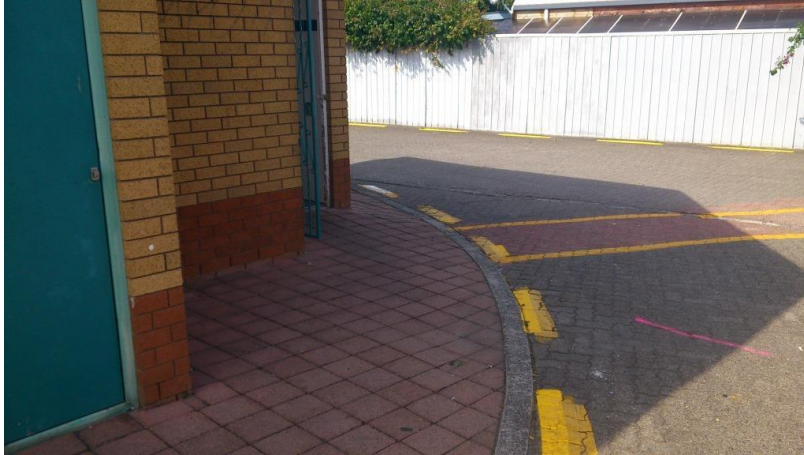
**Figure 52: Walkway at Public Toilets near Port Road**

An area of concern is at the Public toilets near the Port Road end of the walkway. A narrow footpath and steep crossfall makes this section difficult to negotiate.

Widening the footpath by reducing the radius of the curve will improve the crossfall at this point.

**Recommendation 70** Reduce the radius of curve at the Public Toilets near Port Road to improve width and crossfall of the walkway.

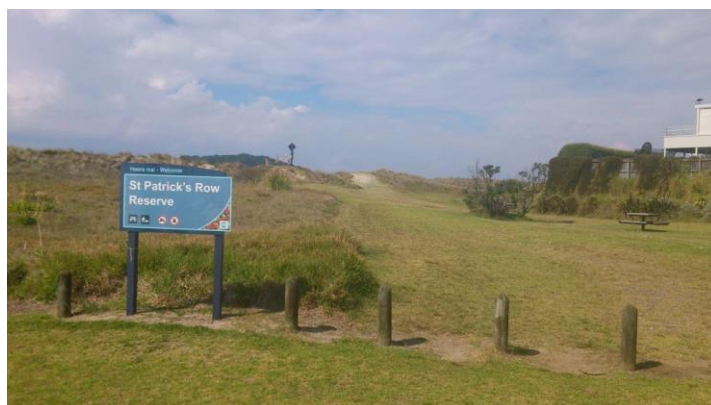
**Figure 53: Beach Access No.7 at St Patricks Row**

Beach Access No. 7 is located off St Patricks Row. By installing a footpath on Beverly Terrace and St Patricks Row, access to this part of the Beach will be improved. Extending the footpath (see Recommendation 43) to the sand dunes and providing an area for viewing will complete this Access.

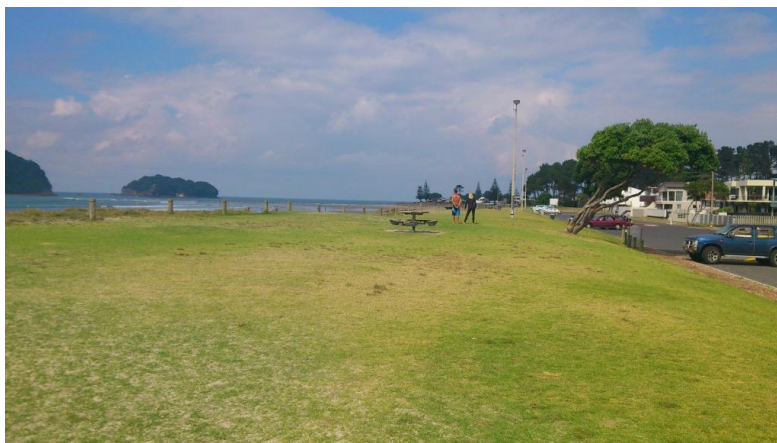
**Figure 55: Raised grassed area between Esplanade Drive and the beach**

Beach Access No. 8 and 9 are situated off Esplanade Drive near the Surf Club. Public Toilets are available at this location and there is a raised grassed area between Esplanade Drive and the beach. This was the preferred location for access to the beach by the attendee's at the Community Consultation Meeting.

Extending the footpath from Lowe Street to the Surf Club and installing a 3m wide path along the raised grassed area to Beach Access No.8 (with associated connection to the footpath from Graham Street at Beach Access No.8) will provide a great viewing area for access users.
